## VAT Pendulum Isolation Valve Repair

- Repair details
- ◆ 1.Problem check : Function and leak test before repair
- ◆ 2.Disassembly & Check : Disassembly all of valve and check each components one by one
- ◆ 3.Clean , Replace damaged & all seals and bearings
- ◆ 4.Assembly
- ◆ 5.Leak Test : Vacuum leak , Isolation Leak and CDA Leak test
- ◆ 6.Function test : Control simulate verify and cycle test
- ◆ 7.Final check packing : heater test and packing

Description	VAT Pendulum Valve	入廠日期	2007/9/7
User		出廠日期	
P/N		S/N	0163
Item	Repair details	Action	Remark
1	Pendulum plate	clean	
2	Bonnet	clean	
3	Sealing Ring	replaced	
4	Valve body	clean	
5	Lift of sealing ring	clean	
6	Valve seat	clean	
7	Bearing of actuator(2 set)	replaced	
8	Bonnet seal	replaced	perfluoro,provide by user
9	Rotary feedthrough(2 ea)	replaced	
10	Seal of actuator(2 ea)	replaced	
11	Plate seal of sealing ring	replaced	perfluoro,provide by user
12	Body seal of sealing ring	replaced	perfluoro,provide by user
13	Lift seal of sealing ring(12 ea)	replaced

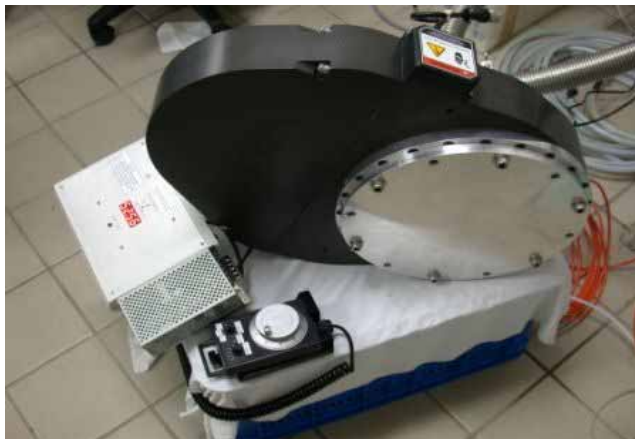
Leak Test

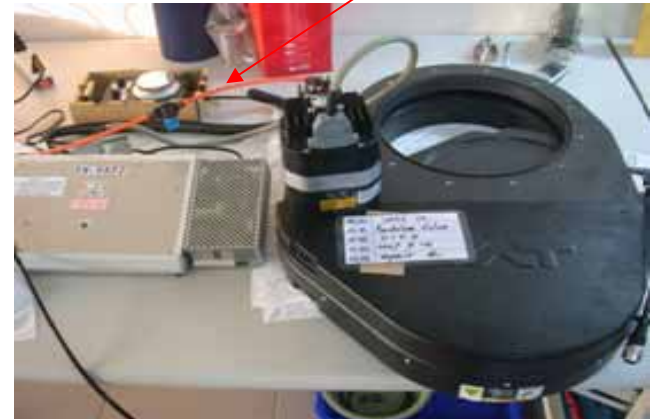
Control Simulator

Simulate Control & Cycle test

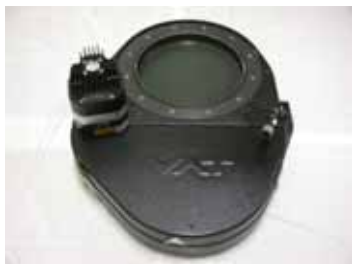
**Valve Assembly**

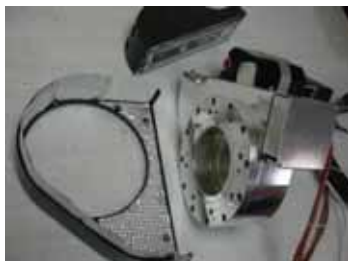
**Body**

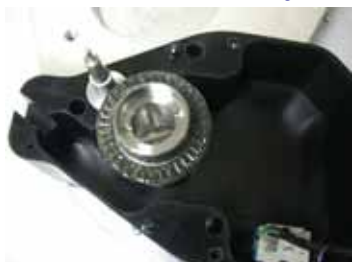
**Pendulum Unit**

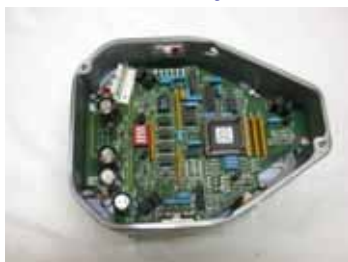
**Control Board**

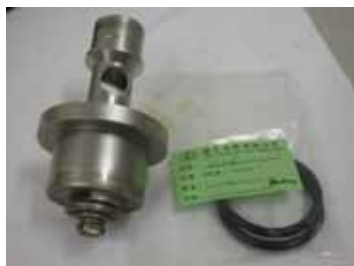
Seal for Pendulum Shaft

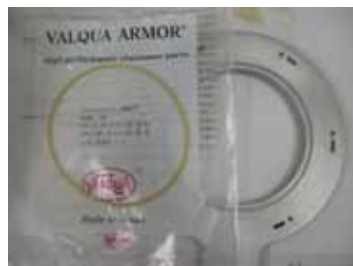
Seal for Isolation Ring

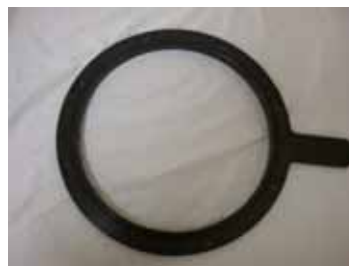
Seal for Bonnet

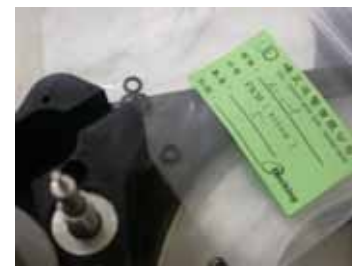
Seal for Actuator

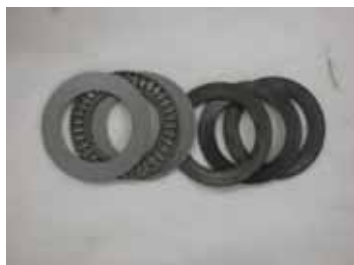
Bearing Set

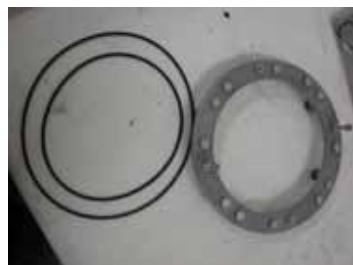
Seal for Sealing Ring

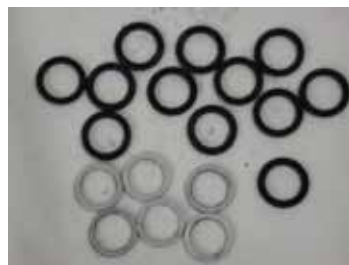
Lift Seal for Sealing Ring

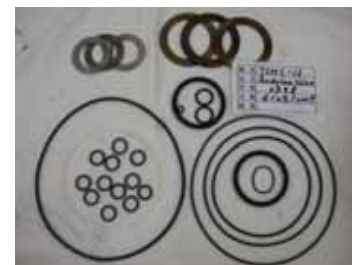
Replace Seals

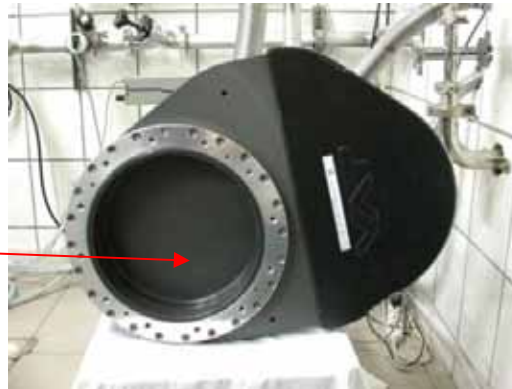
Check if  
leak here

Isolation Leak Test

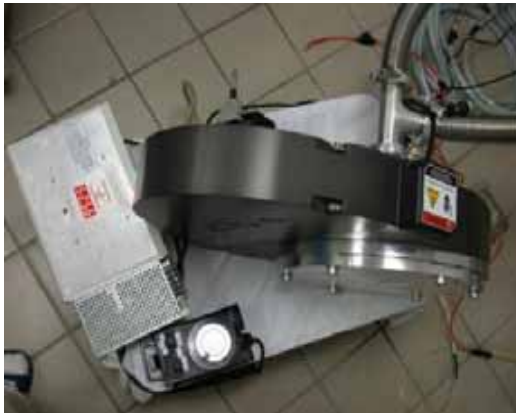
Open Leak test

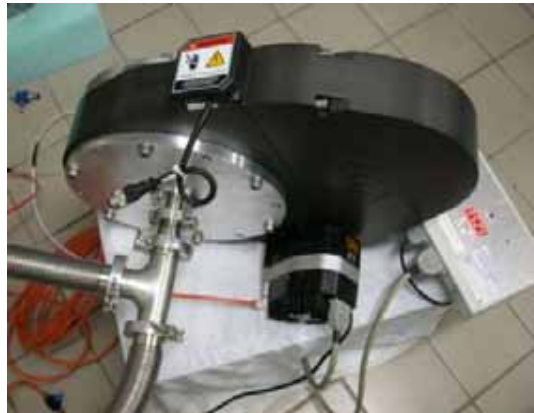
Close Leak test

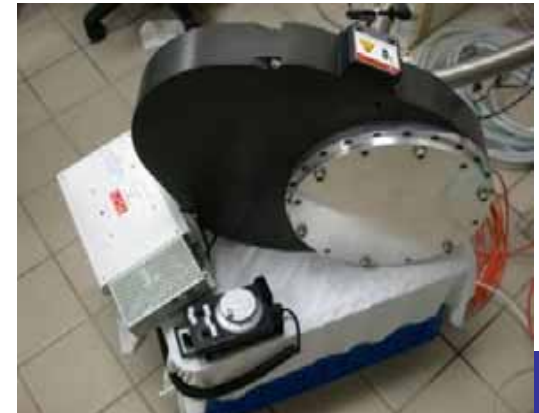
CDA Leak test

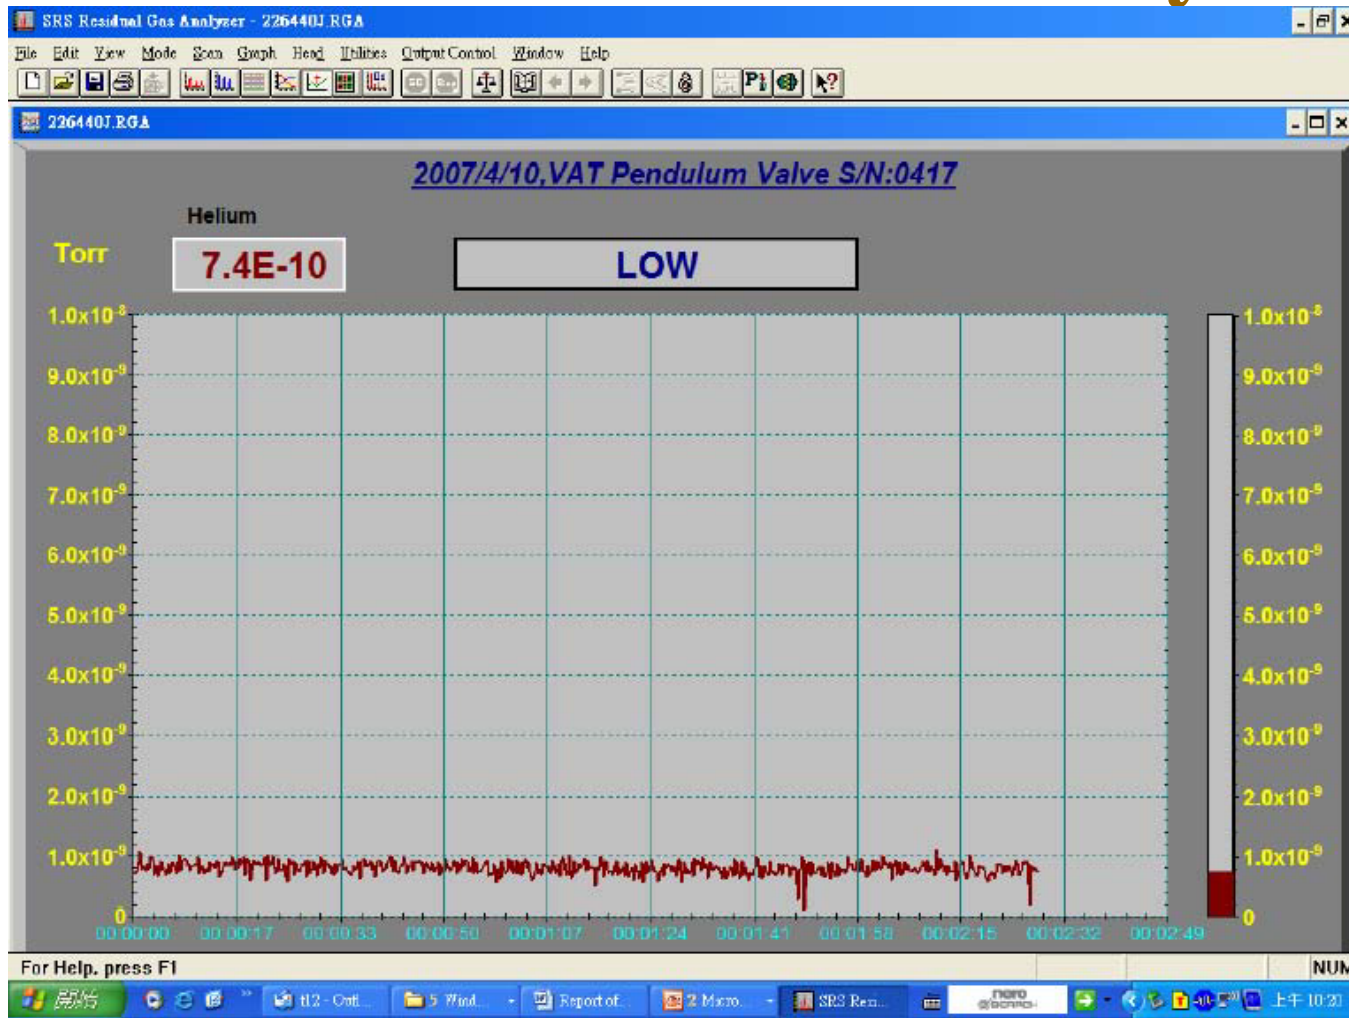
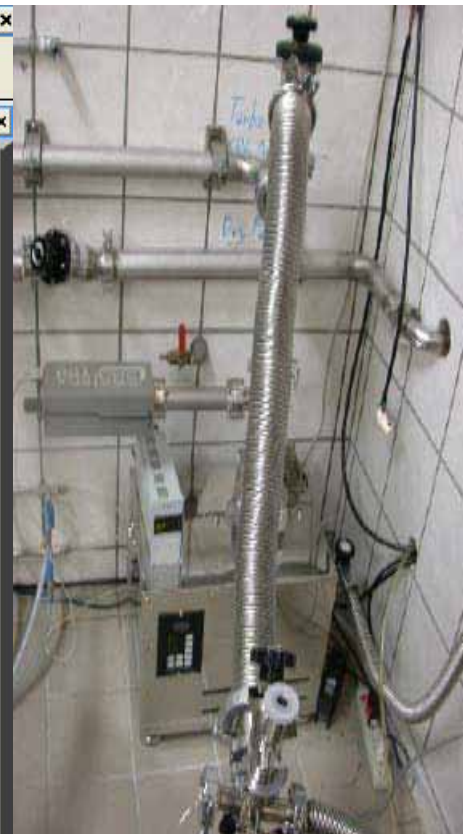
## Result Of Leak Test By RGA

Item	Vacuum Leak Check	Result	
1	Vacuum Leak test (Torr-Liter/sec)	-3.7E-09	
2	Vacuum Leak test inner gas (Torr-Liter/sec)	-4.1E-09	
Item	OQC	Result	
1	Accessories check.	OK	
2	Final visual check	OK	
REMARK

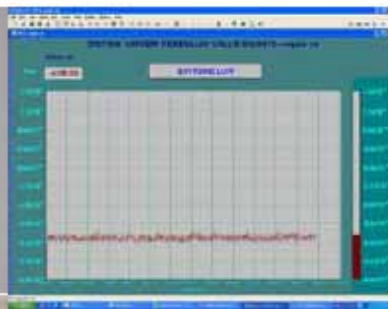
leak test(closed plate)

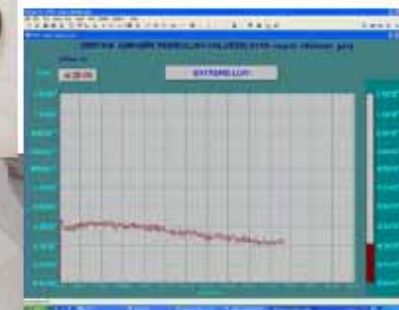
leak test (inner gas)
